# HomeShield Inspections

## October 27th 2023, 12:30 pm

**BUILDING ADDRESS:** 2245 High St.

**CITY:** Oakland

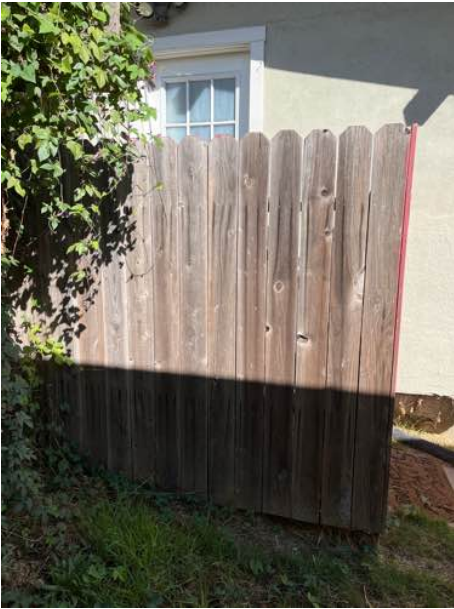
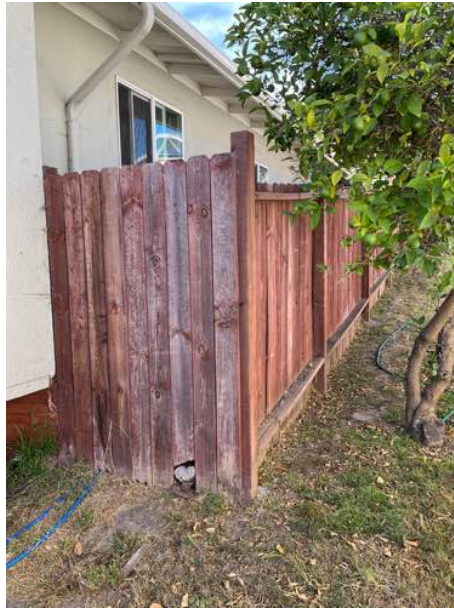
**FENCE** Satisfactory

Fence structure is good. Hole at the bottom of the fence as seen in picture. This is not necessarily cause for alarm, but something any homeowner should be aware of.

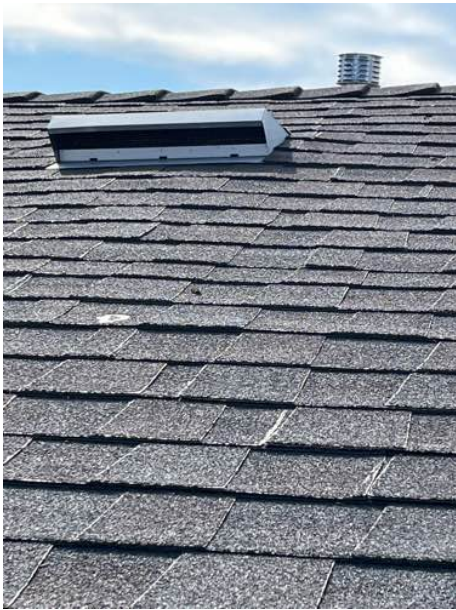
**SHINGLES MISSING / DAMAGED? Fair**

Some roof warping present which could indicate moisture damage. Continue to monitor, if condition deteriorates contact a qualified contractor.

Continue to monitor, if condition deteriorates contact a qualified contractor.

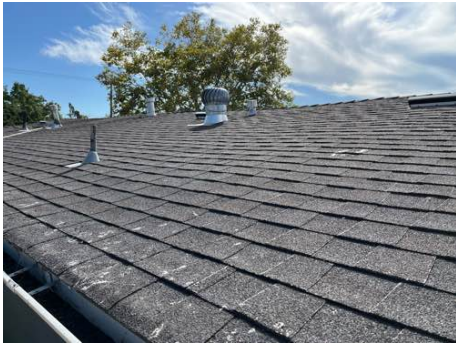
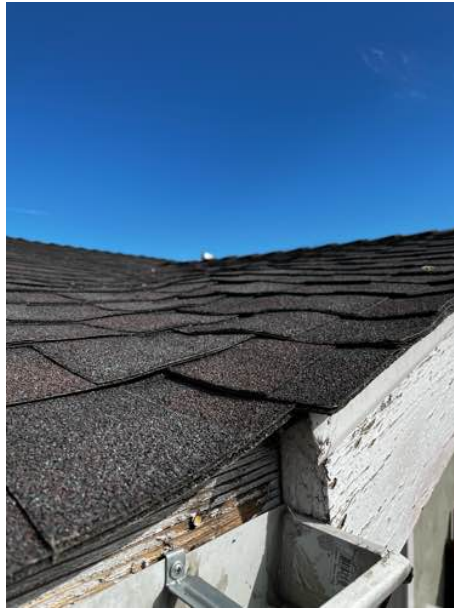
**ROOF INSTALLATION Fair**

Keep an eye on roof condition.

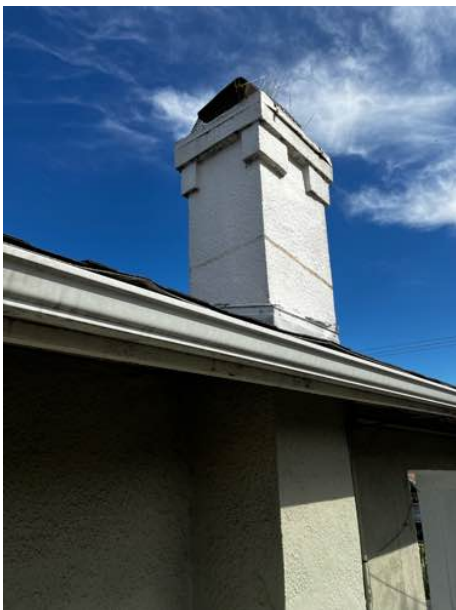
**CHIMNEY** Satisfactory

No visible cracking on outer chimney. Some de Bree stuck in spark arrestor. This is not necessarily cause for alarm, but something any homeowner should be aware of.

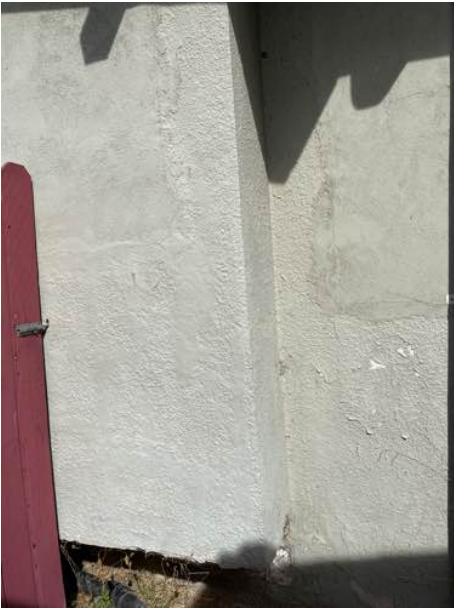
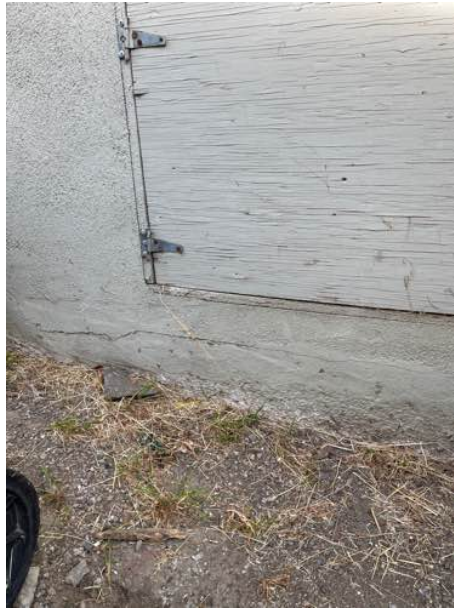
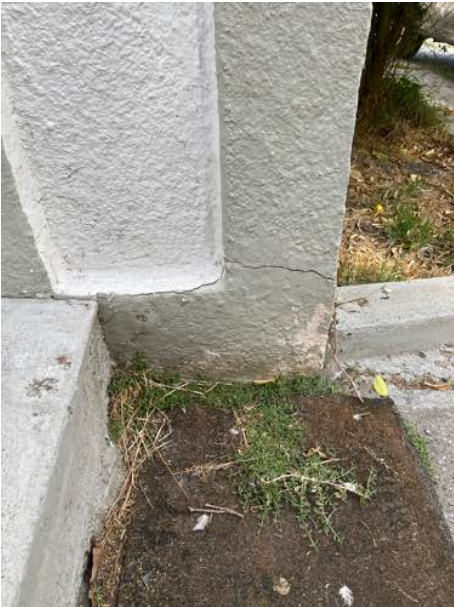
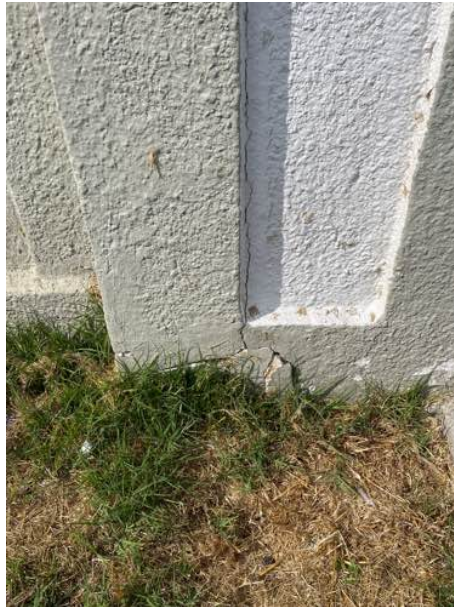
**SIDING MATERIAL** Stucco

Some cracking stucco on the exterior of the home.

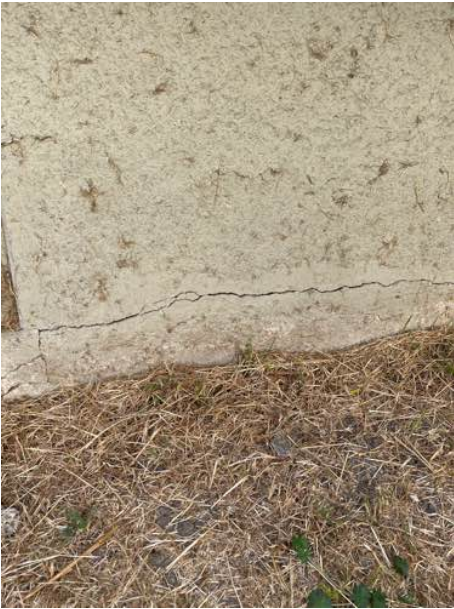
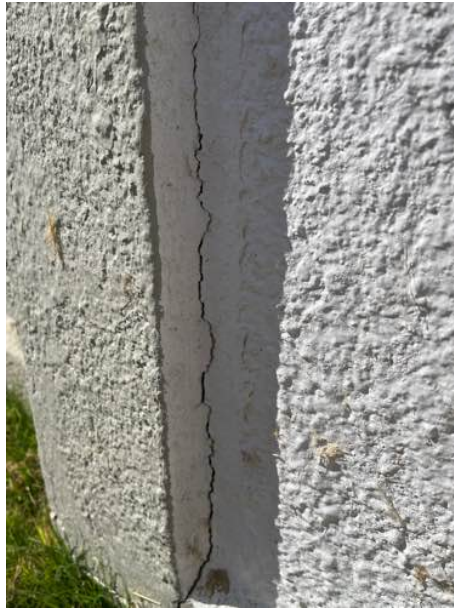
**SIDING CONDITION** Fair

Some visible horizontal and vertical cracking at the time of inspection. Continue to monitor, if condition deteriorates contact a qualified contractor.

Continue to monitor, if condition deteriorates contact a qualified contractor.

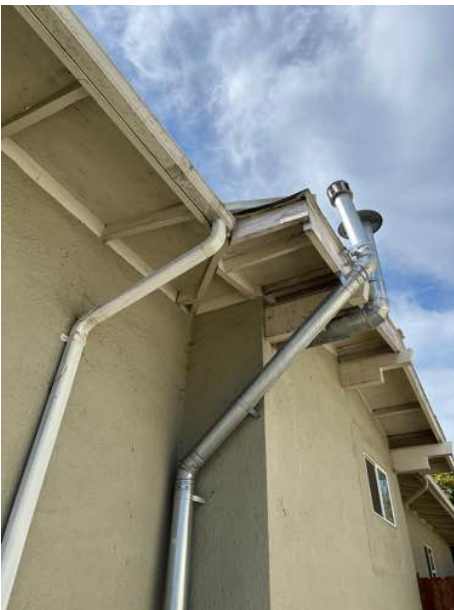
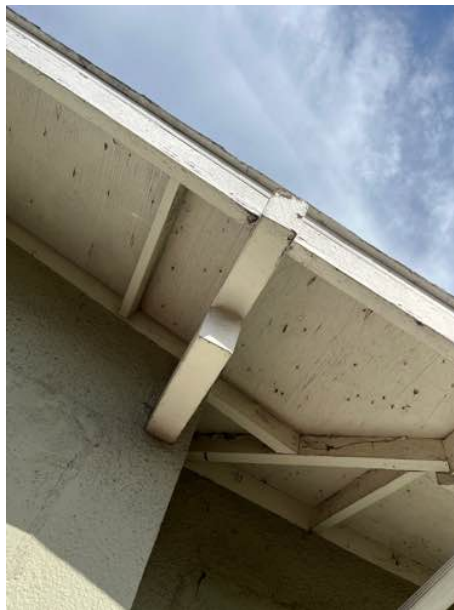
**EAVES** Satisfactory

Some damage and paint peeling on wood.

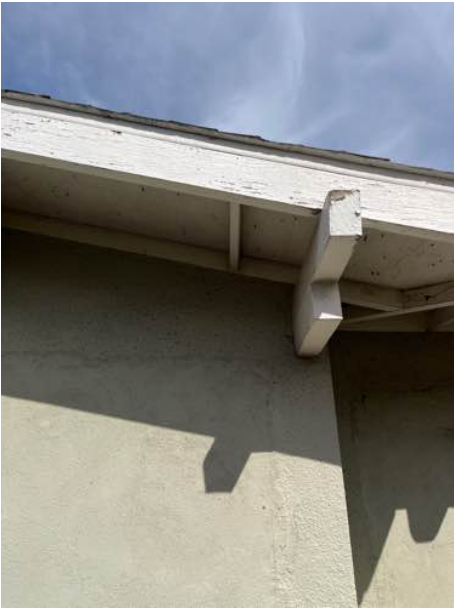
**FASCIA** Satisfactory

Paint peeling noted during time of inspection.

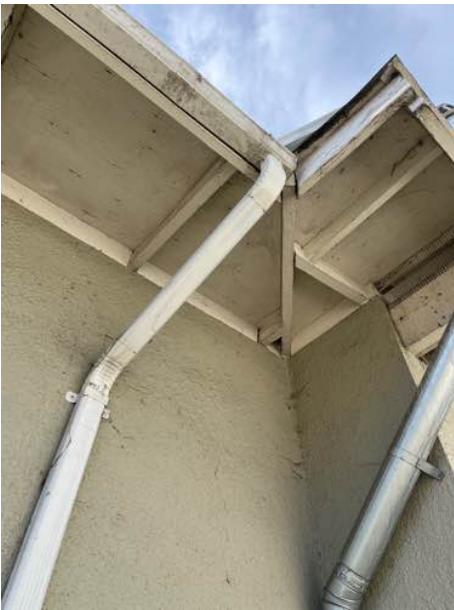
**SOFFITS** Satisfactory

Paint peeling noted during time of inspection.

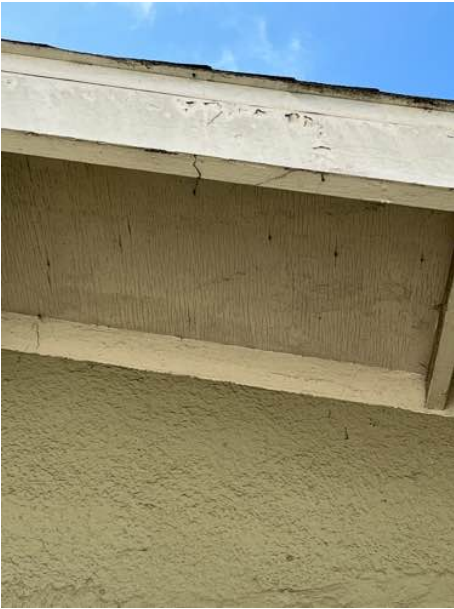
**TRIM** Satisfactory

Paint peeling noted during time of inspection.

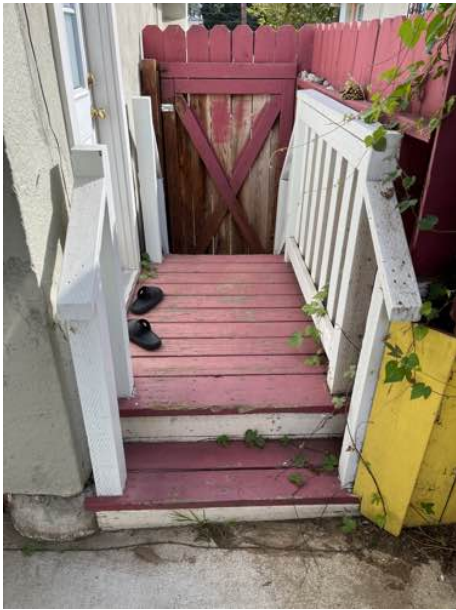
**DECKS** Satisfactory

Deck is secure, just some paint chipping at time of inspection

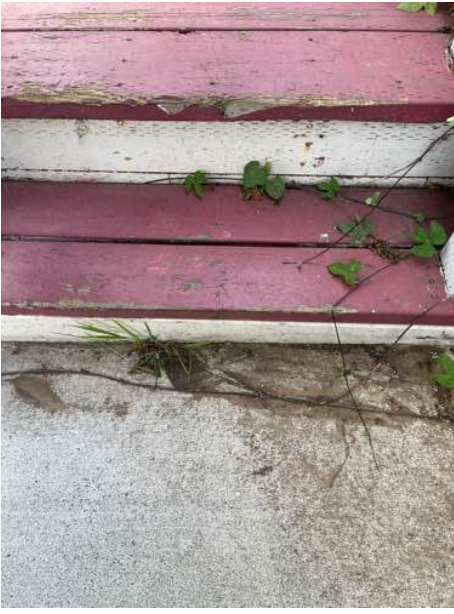
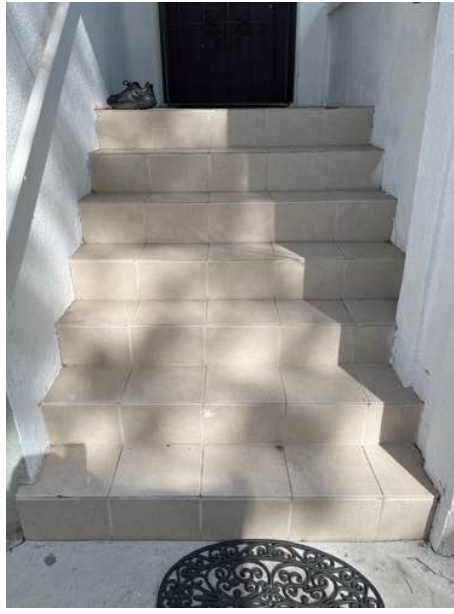
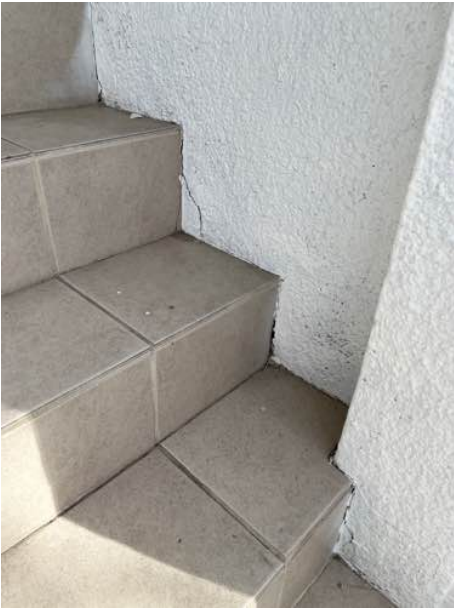
**STEPS** Satisfactory

Stairs are sturdy with no loose boards, just some cracking and chipped paint noted during time of inspection.

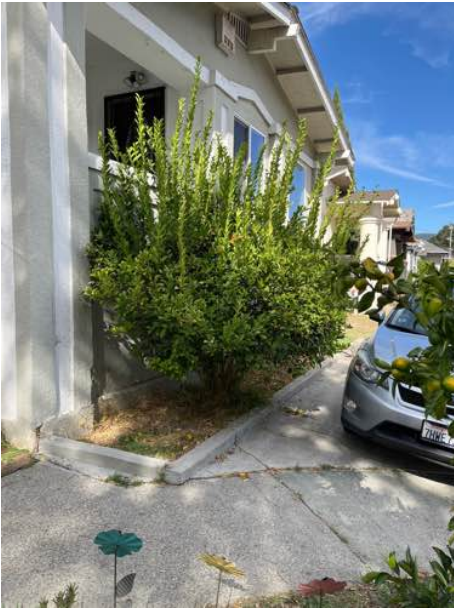
**VEGETATION** Fair

Tree brushing against siding of house. This is not necessarily cause for alarm, but something any homeowner should be aware of due to possible moisture.

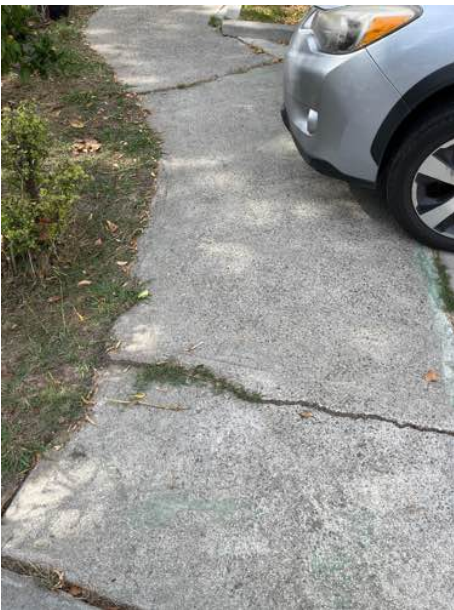
**WALKWAYS** Fair

Some cracking noted at time of inspection.

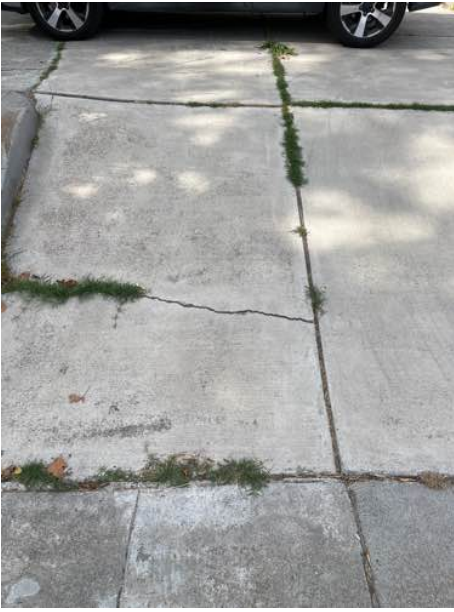
**DRIVEWAY** Satisfactory

Some cracking noted at time of inspection.

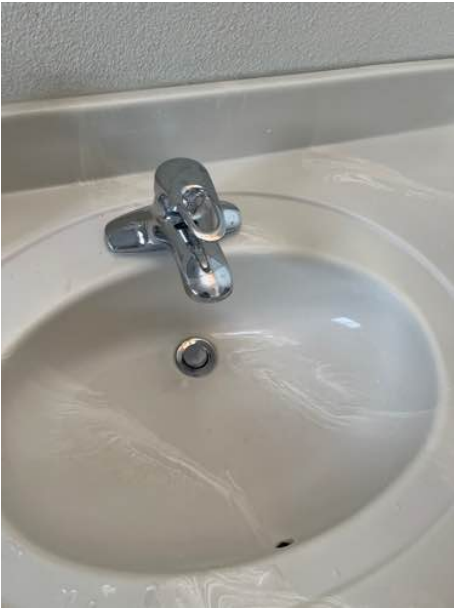
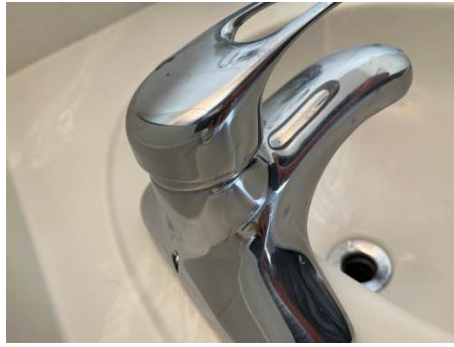
**SINKS** Fair

The bathroom sink did not have a sink stopper installed during inspection. Recommend repair / replacement by a homeowner or handyman. No visible leaks under sink during inspection.

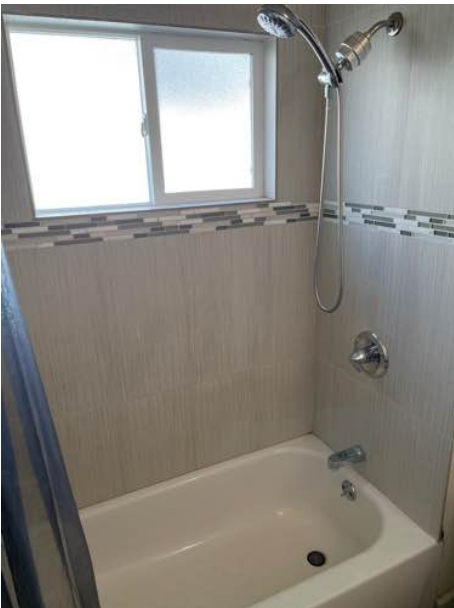
**BATHTUB / SHOWER** Satisfactory

Minor cosmetic discoloring in between tiles on shower noted. Shower head, tub spout and tub drain all operable during inspection.

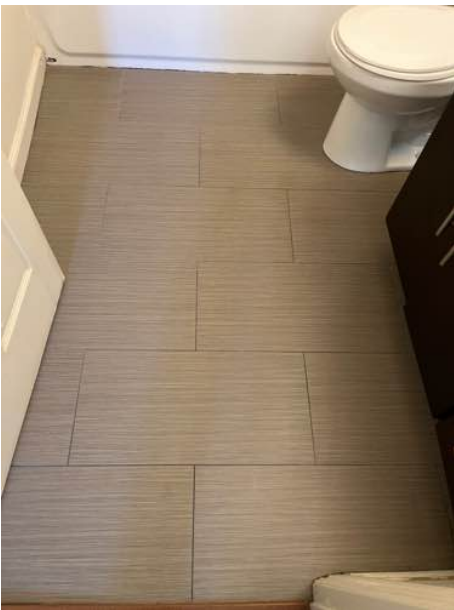
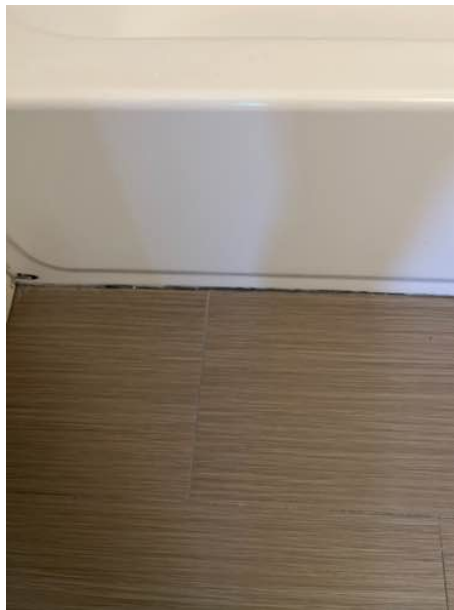
**FLOORING** Satisfactory

Separation on floor next to tub, recommend caulking.

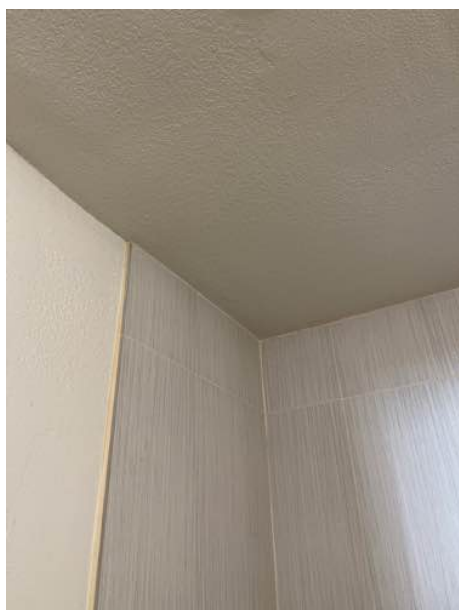
**CEILING** Satisfactory

Cracking where ceiling meets wall noted.

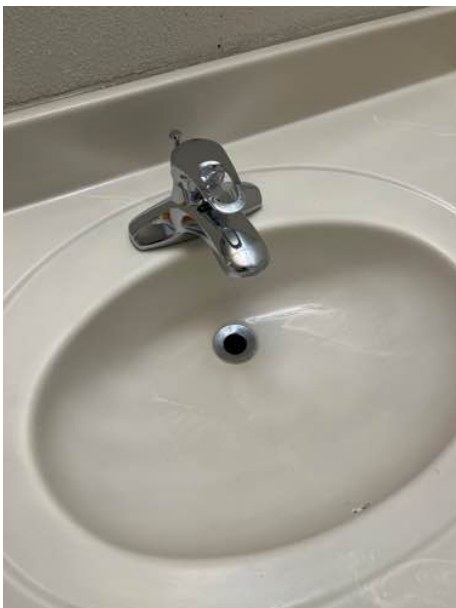
**SINKS** Fair

The bathroom sink appeared to have a broken sink stopper during inspection. Recommend repair / replacement by a homeowner or handyman. No visible leaks under sink during inspection.

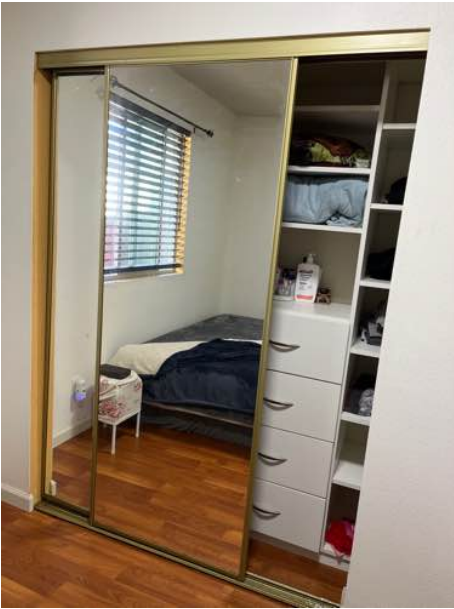
**CLOSETS** Fair

Crack on 1 mirror door and 1 of the sliders is difficult to slide during inspection.

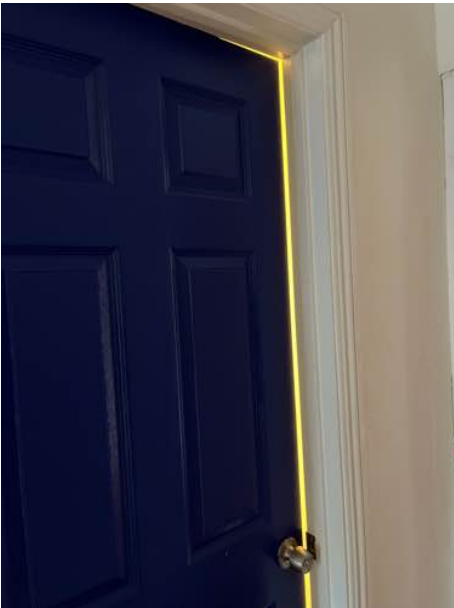
**DOORS** Poor

Door does not close all the way and gets jammed during inspection.  
Recommend repair / replacement by a homeowner or handyman.

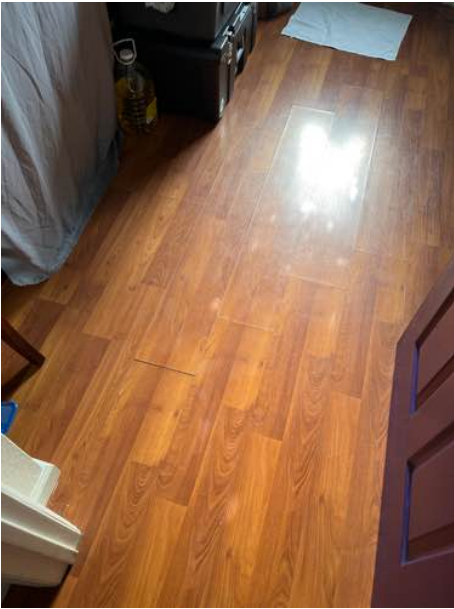
**FLOORING** Fair

Some separation of floor panels noted during inspection. Continue to monitor, if condition deteriorates contact a qualified contractor.

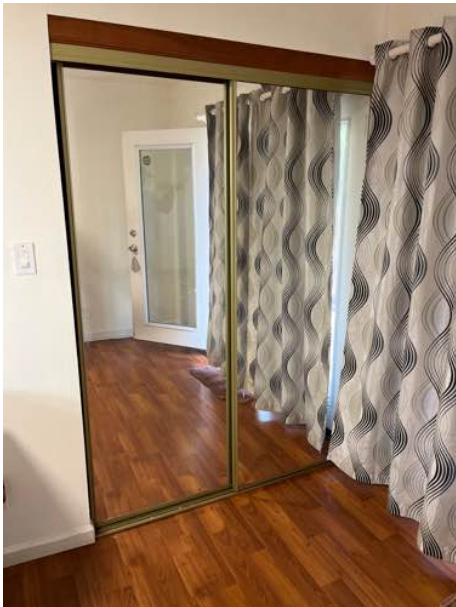
**CLOSETS** Fair

Closet doors are somewhat difficult to slide during inspection. This is not necessarily cause for alarm, but something any homeowner should be aware of.

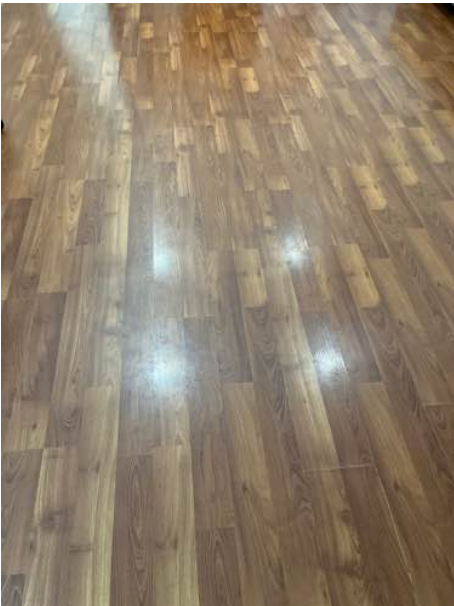
**FLOORING** Fair

There is some sloping on floor near the entrance of home. Continue to monitor, if condition deteriorates contact a qualified contractor.

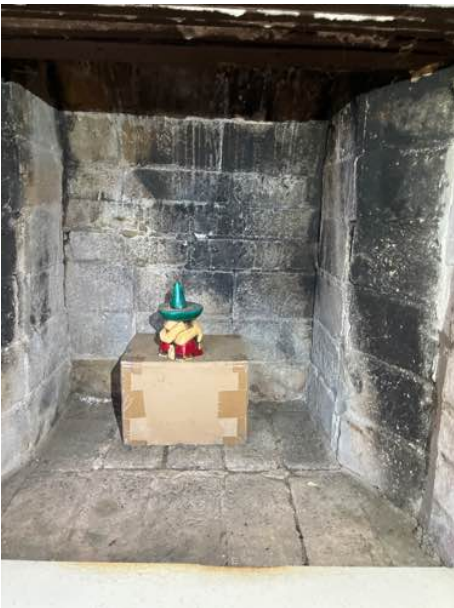
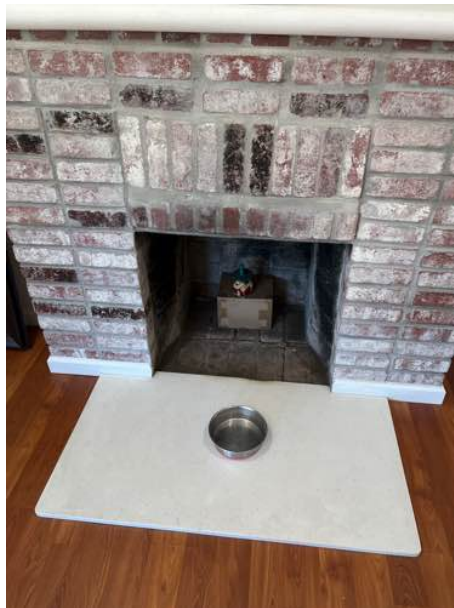
**FIREPLACE** Poor

Step cracking noted on the masonry of the fireplace. Recommend further evaluation by a qualified Masonry contractor.

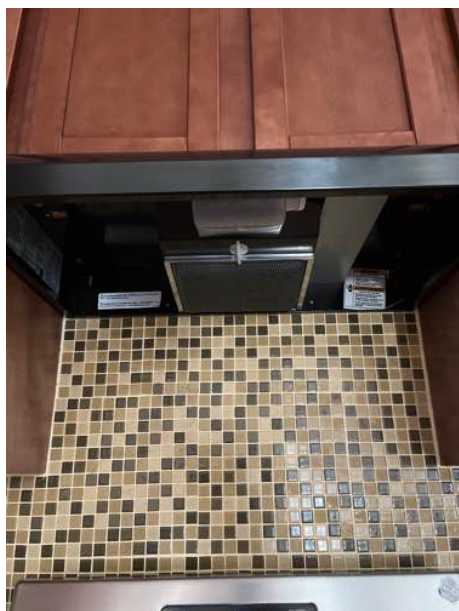
**EXHAUST HOOD** Fair

Light needs replacing on exhaust hood. Recommend repair / replacement by a homeowner or handyman.
